**Thermographic Report – Building, San Francisco, CA 93955**

In September 2009, Agrarius LLC was commissioned to study a three story office building located at Building, San Francisco, CA. Folsom Street, street level views are provided below.

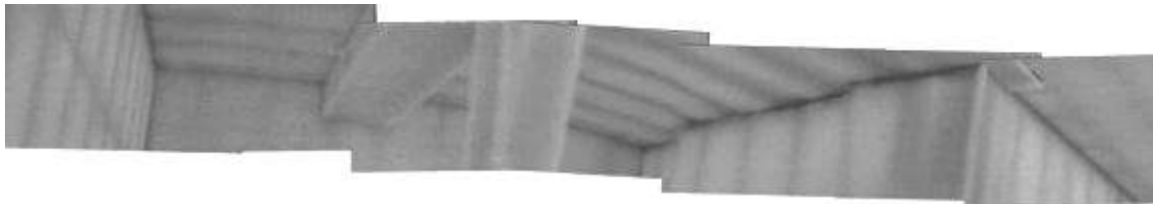
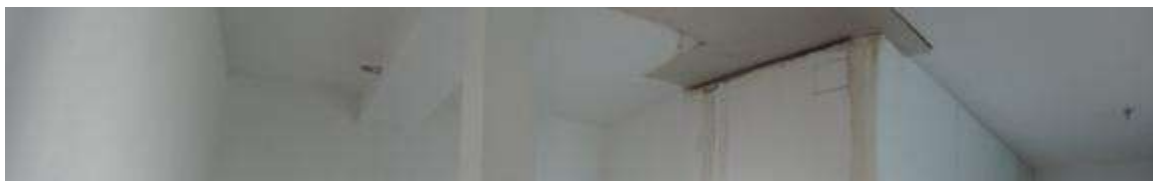
On 2 September the interior was imaged to establish a dry baseline of the building interior. Infrared and visual images of all walls and floor surfaces adjacent to the walls were observed and numerous views were collected to establish the base (dry) condition of the building interior. Figure 2a and 2b are a sample composite of thermal images (figure 2a) and the companion visual (figure 2b) of a dry ceiling and joining walls in the building. Note the feature in the upper left of the images. It is a patch that was applied after the damage caused by the rain in January 2009.

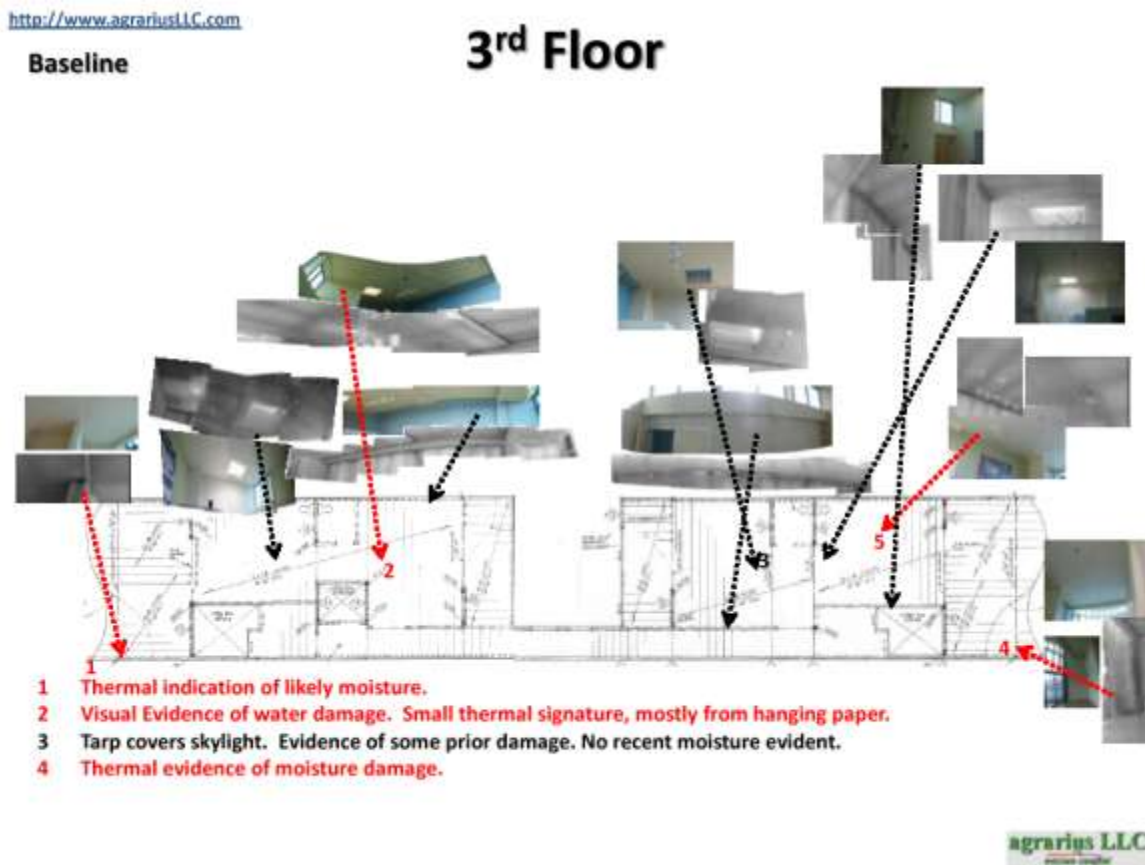
Figure 3 3<sup>rd</sup> Floor, 2 Sept

The 3<sup>rd</sup> Floor imaging shows a number of damaged points in the ceiling. Some are seen in the visual images as stained locations and torn paper. Others are only detectable in the thermal images (see Building Survey Imagery-2Sep09). However, there are no significant thermal indications of moisture present.

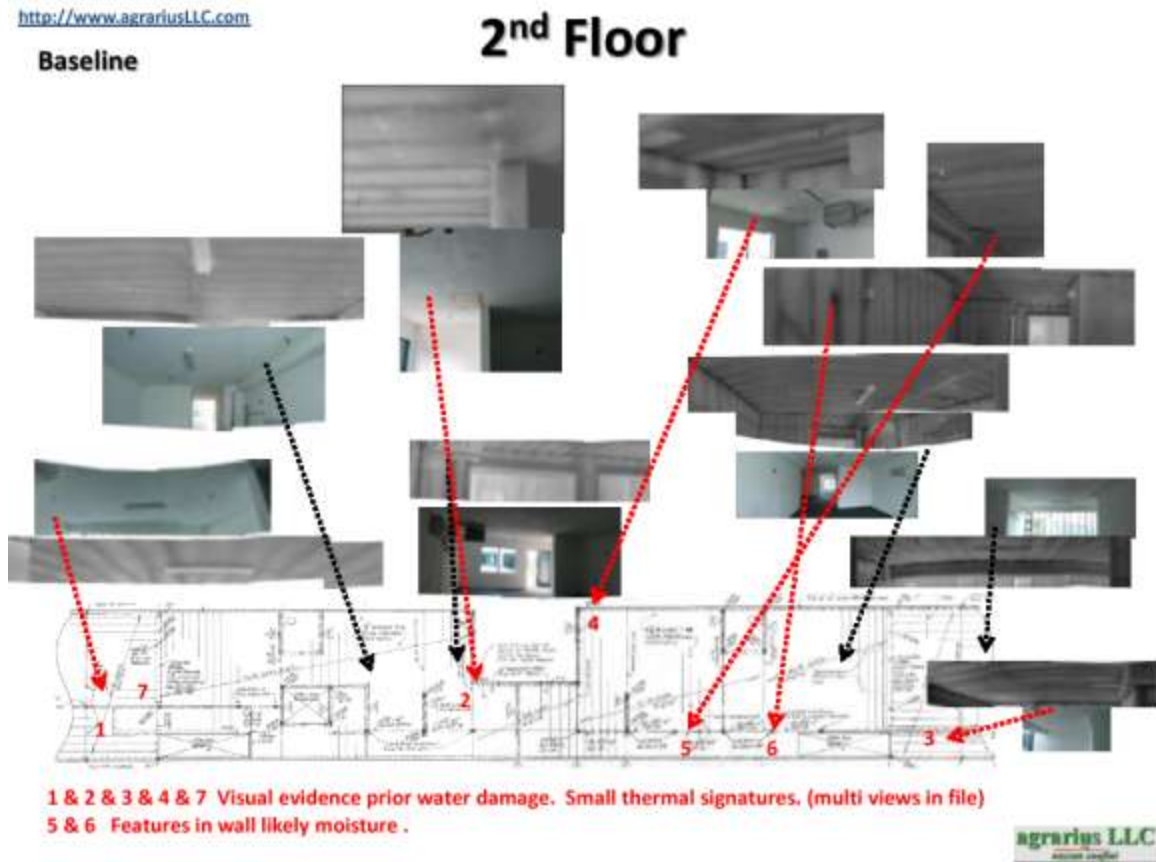
Figure 4 2nd Floor, 2 Sept

The 2<sup>nd</sup> Floor imaging shows damaged points in the ceiling and wall. Some are seen in the visual images as stained locations and torn paper. Others are only visible in the thermal images (see Building Survey Imagery-2Sep09). On the second floor, damage at locations 1 and 3 line-up under damaged locations 1 and 4 on the third floor. Note that at some of the locations where damage is visible in the visual picture (water stains and torn paper), very little is evident in the thermal view because the ceiling board has completely dried and no major damage to the ceiling board material was sustained. For example, figure 5, below demonstrates a view of a fully dried section of ceiling.

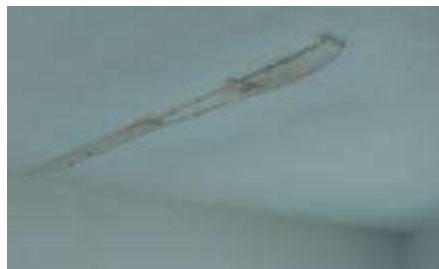
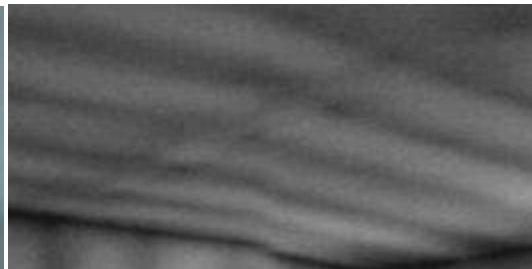
Figure 5a Visual 'scar'

Figure 5b Thermal 'scar'

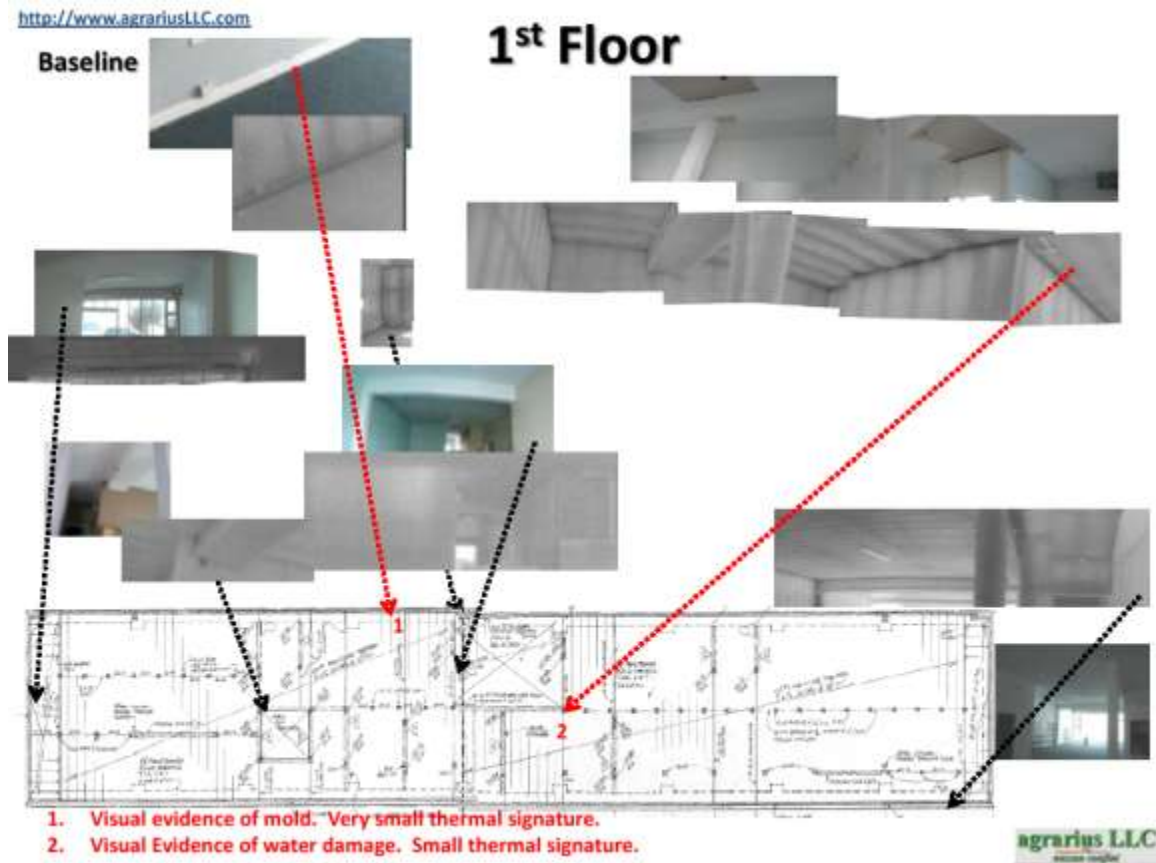
Figure 6 1st Floor, 2 Sept

On the 1<sup>st</sup> Floor (Figure 6) although there are a few locations where there is visual evidence of prior damage there are no significant thermal indications of moisture present.

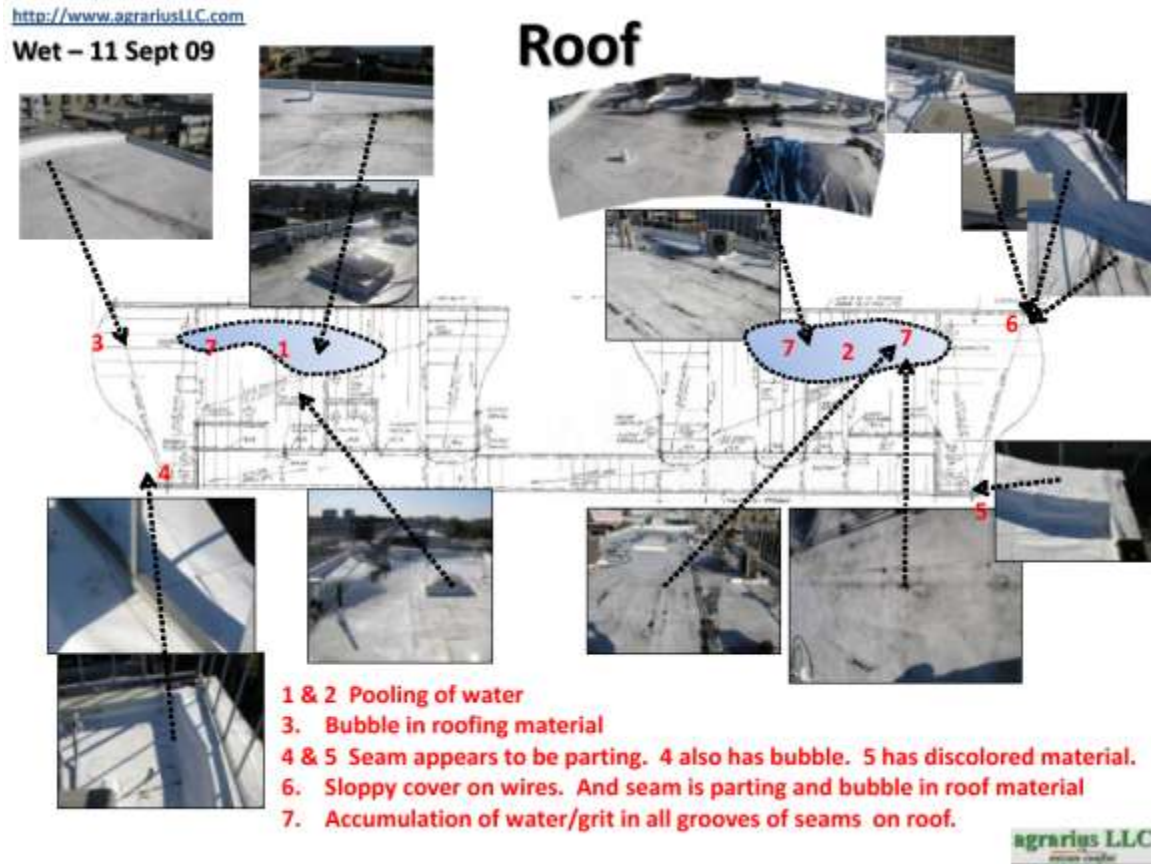
Figure 7 Roof, 11 Sept

In the annotated Roof (Figure 7) panel it is important to note that after wetting the roof, both north and south roofs had large puddles that were as deep as 2 inches at the centroids. There are also a number of locations (4, 5, and 6) where the seam appears to be pulling apart.

Moving to the floors below (3<sup>rd</sup> Floor, 2<sup>nd</sup> Floor, 1<sup>st</sup> Floor), it is seen that the defects pointed to on the Roof are highly location correlated to the locations on the floors below where water/moisture is evident. The following set of images illustrates this at one location. The ceiling in room 304 was dry on 2 September and then after wetting the roof on 11 September it is wet.

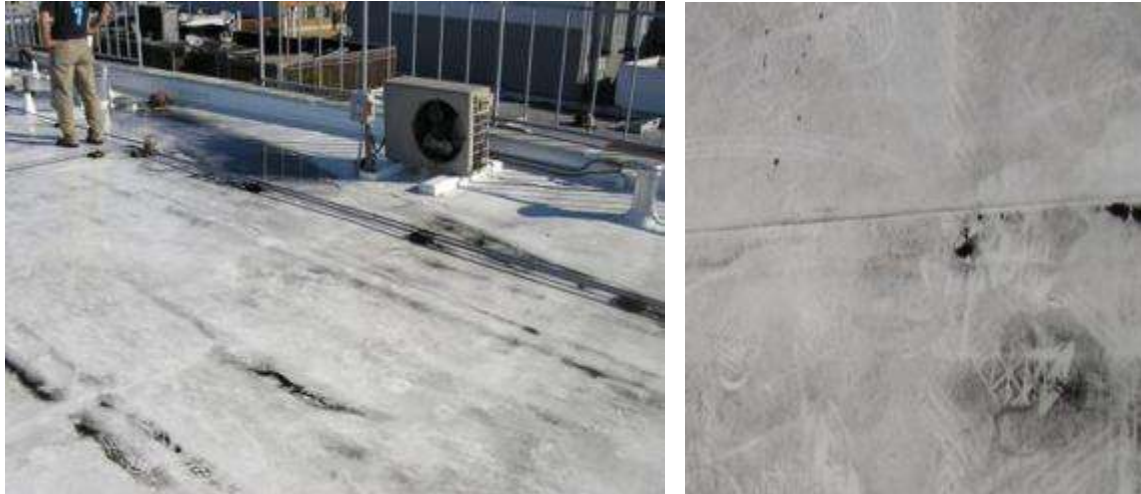
Note that Figure 8 shows a puddle formed on the south roof top. Also note the character of the seams joining the roofing material. This pattern in the roofing material, exposed seams, is typical of all the seams that join long 5 ft wide strips of roofing material on the flat roof. Where there are puddles, the seams are covered by water.

Figure 8 Water puddle on south roof and detail of roofing material seam

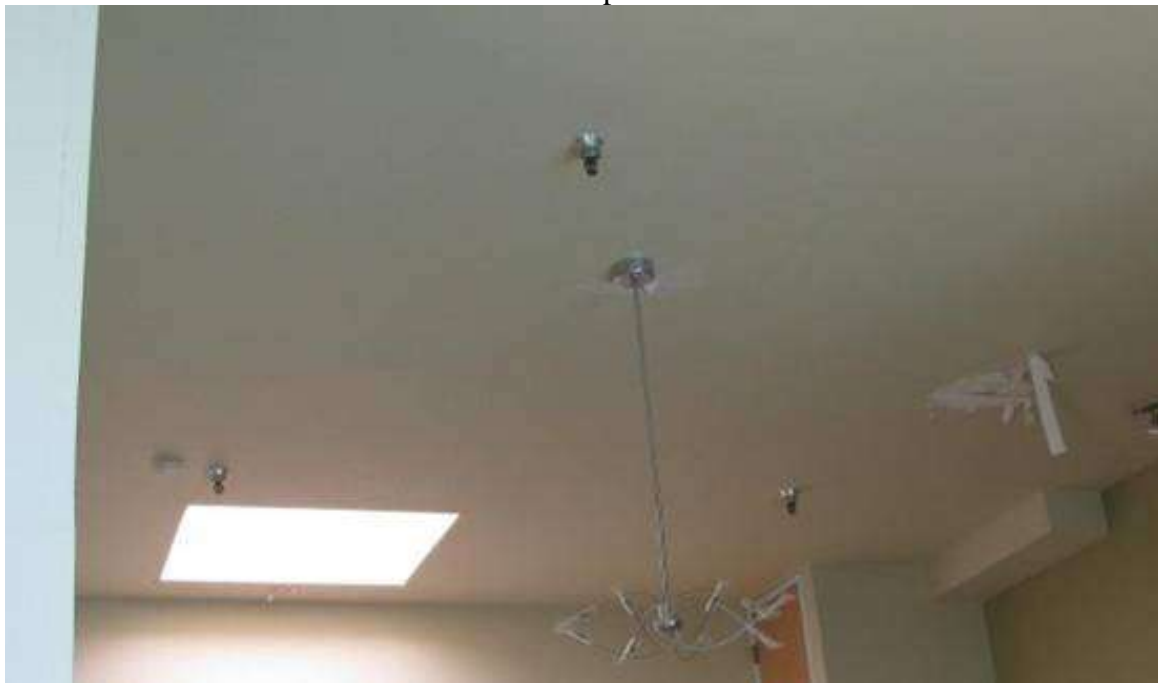
Figure 9 Visual view of room 304 ceiling

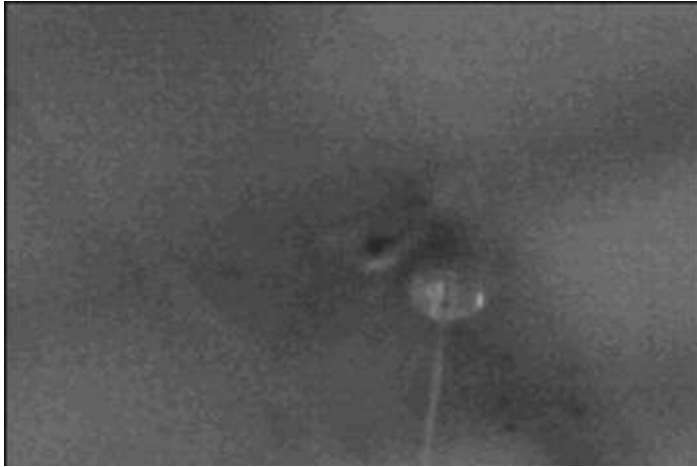
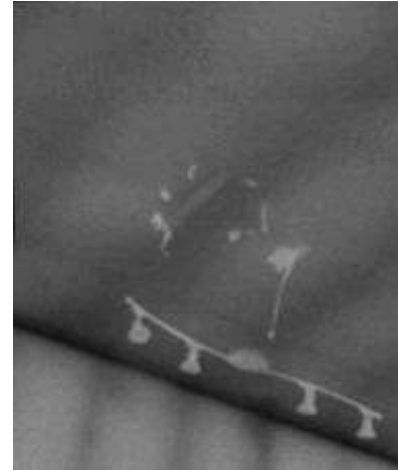
The following image (Figure 10a and 10b) is the thermal view of the ceiling on 2 September when the ceiling was dry. Note the two spots where there was visible damage from the winter rains. Figure 10a corresponds to the location where the light fixture joins to the ceiling and figure 10b corresponds to the location where the paper ceiling cover is seen to be peeling and hanging.

Figure 10a Thermal of light fixture joining ceiling

Figure 10b Thermal of paper peeling

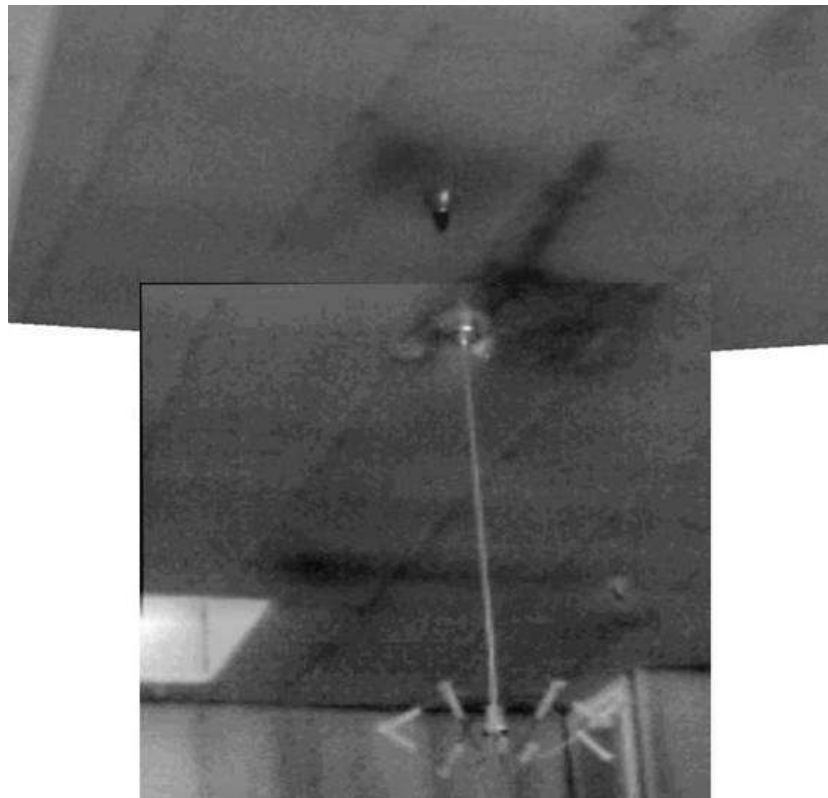
Figure 11 is the thermal view of the ceiling after the roof above was wet on 11 September and a puddle formed on the roof above.

Figure 11 Thermal of ceiling in room 304

The dark (cool) shading is the thermal signature of water/moisture that has been introduced into the ceiling.

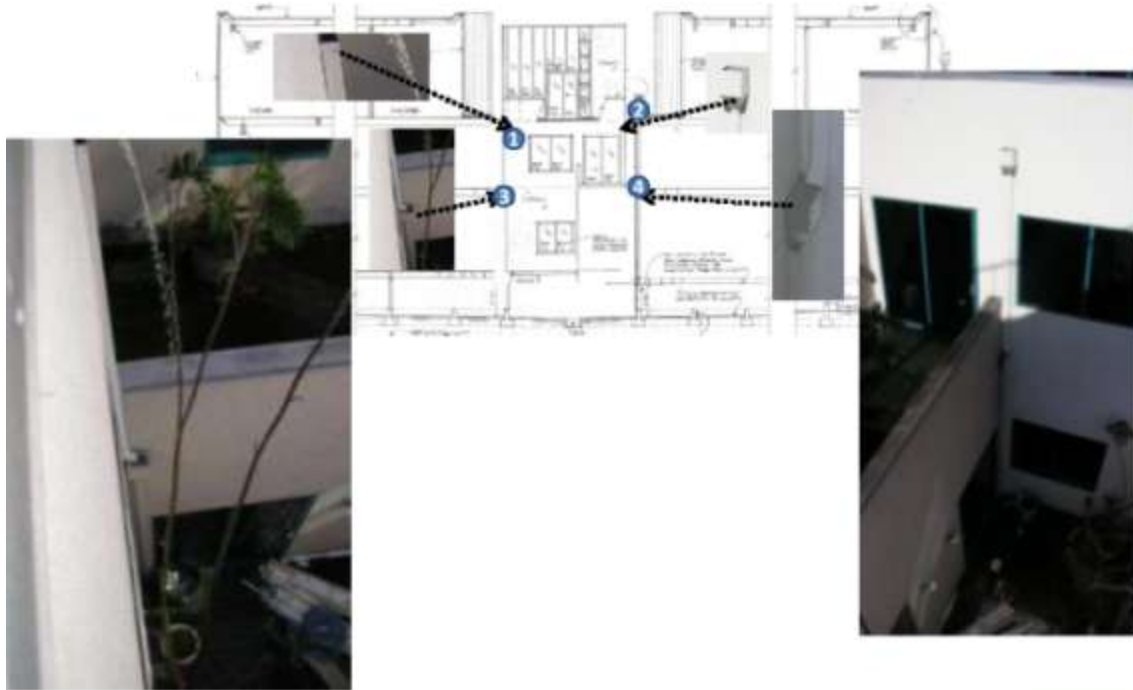
Figure 12 Courtyard/Balconies, 11 Sept

In the annotated Courtyard/Balconies panel (Figure 12) it is important to note that after wetting the balconies the drainage of water through the drains and down spouts is faulty. The balconies did not drain well and it is evident in the visual imagery that both the north and south balcony drains and scuppers do not fit onto the down spots drains. Note that the down spots disperse the water onto (and maybe into) the building rather than down the spouts and away from the building.

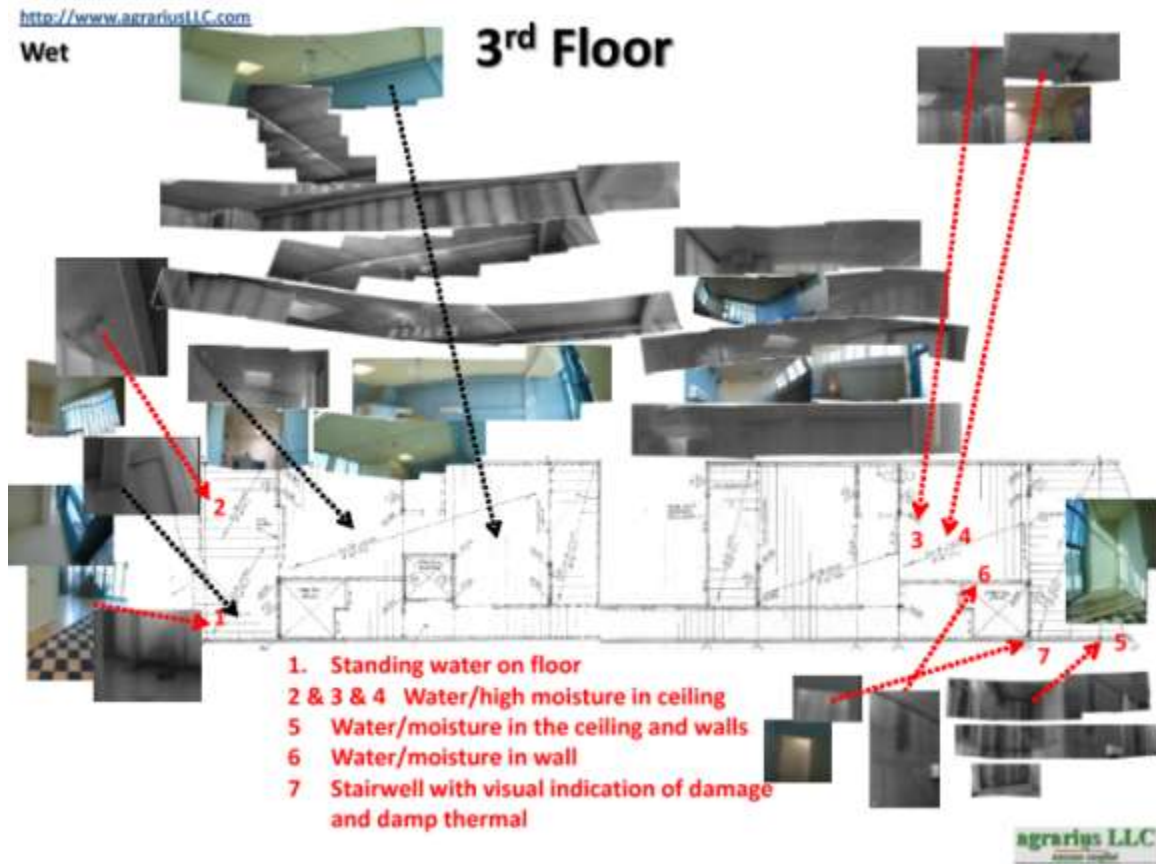
Figure 13 3rd Floor, 11 Sept

Note that the locations of water/moisture at 1, 5 and 7 are directly below locations 4 and 5 from Figure 7 (Roof). Location 2 is below location 3 from Figure 7 (Roof) and the other 3<sup>rd</sup> floor water/moisture locations noted in the ceiling are in proximity to the water puddles on the roof.

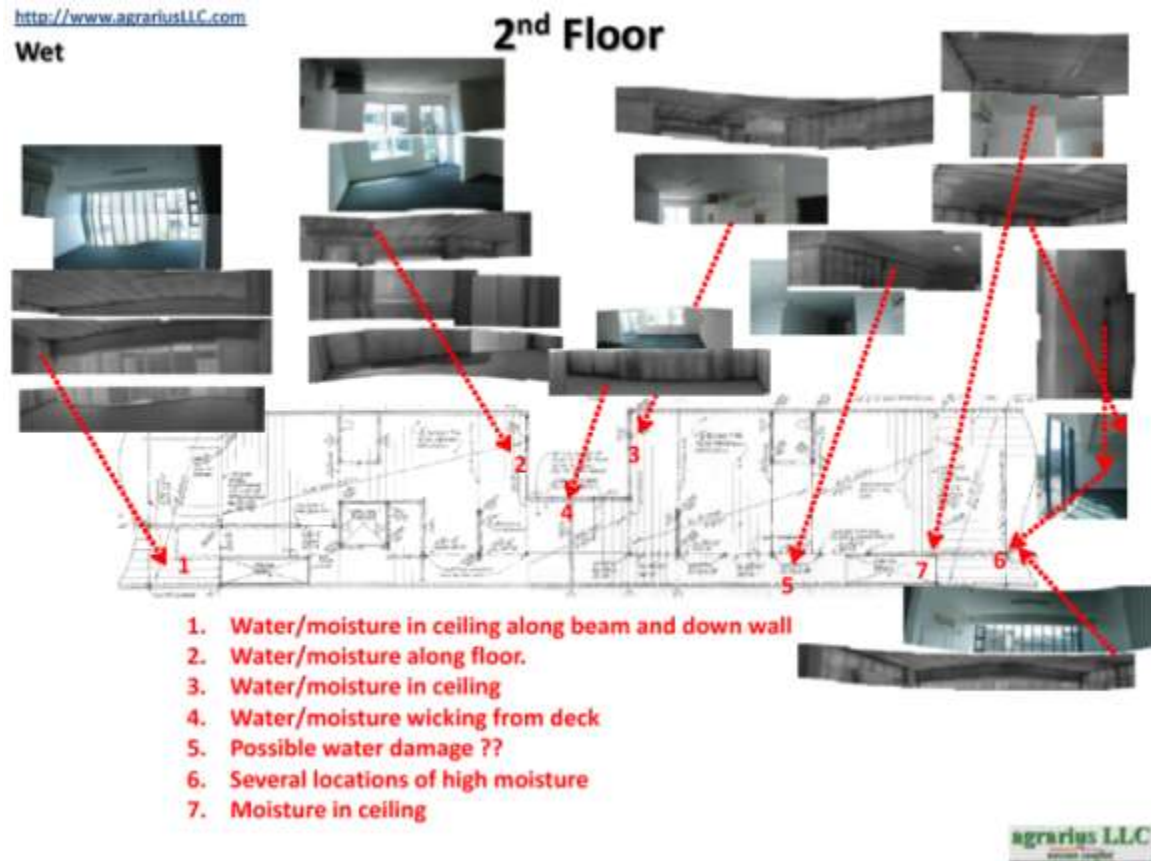
Figure 14 2<sup>nd</sup> Floor, 11 Sept

Note that the locations of water/moisture at 1, 6 and 7 are directly below locations 4 and 5 from Figure 7 (Roof), and Locations 1, 5 and 7 in Figure 13 (Courtyard/Balconies). Location 2, 3, and 4 are all in proximity to the balcony on the 3<sup>rd</sup> floor above.

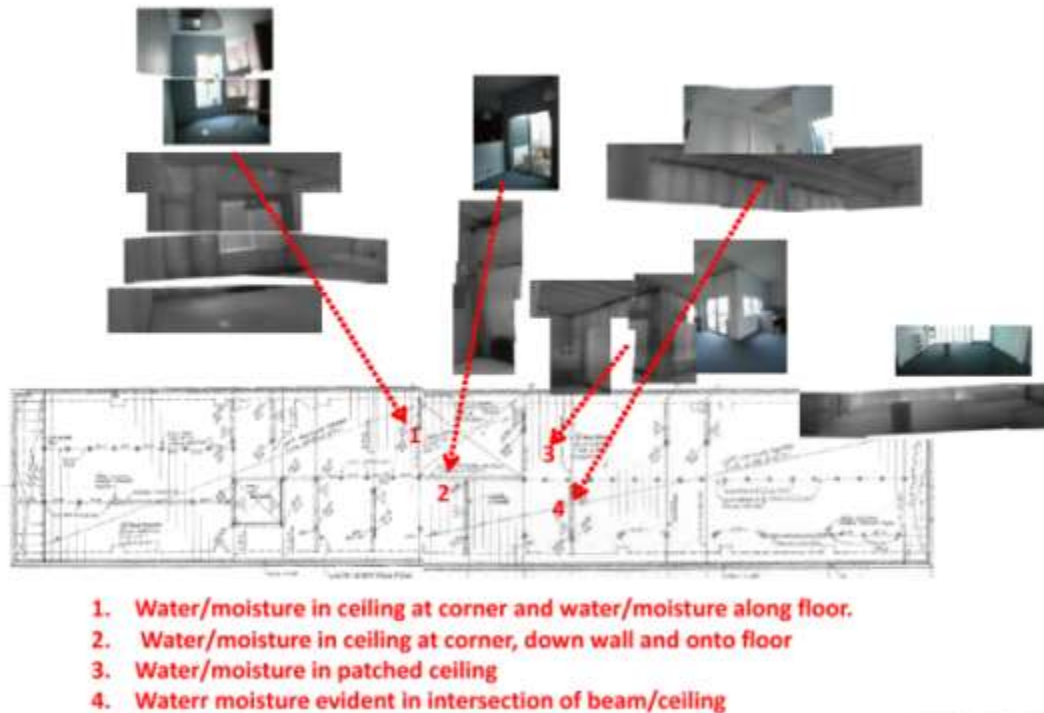
Figure 15 1st Floor, 11 Sept

Note that the locations of water/moisture at 1, 2, 3 and 4 are below the damaged areas pointed out on the 2<sup>nd</sup> floor in proximity to the balconies.
